USAAVLABS TECHNICAL REPORT 65-68

GROUND AND FLIGHT TESTS,  
XV-9A HOT CYCLE RESEARCH AIRCRAFT

C. W. Pieper

SUMMARY REPORT  
HTC-AD 65-13

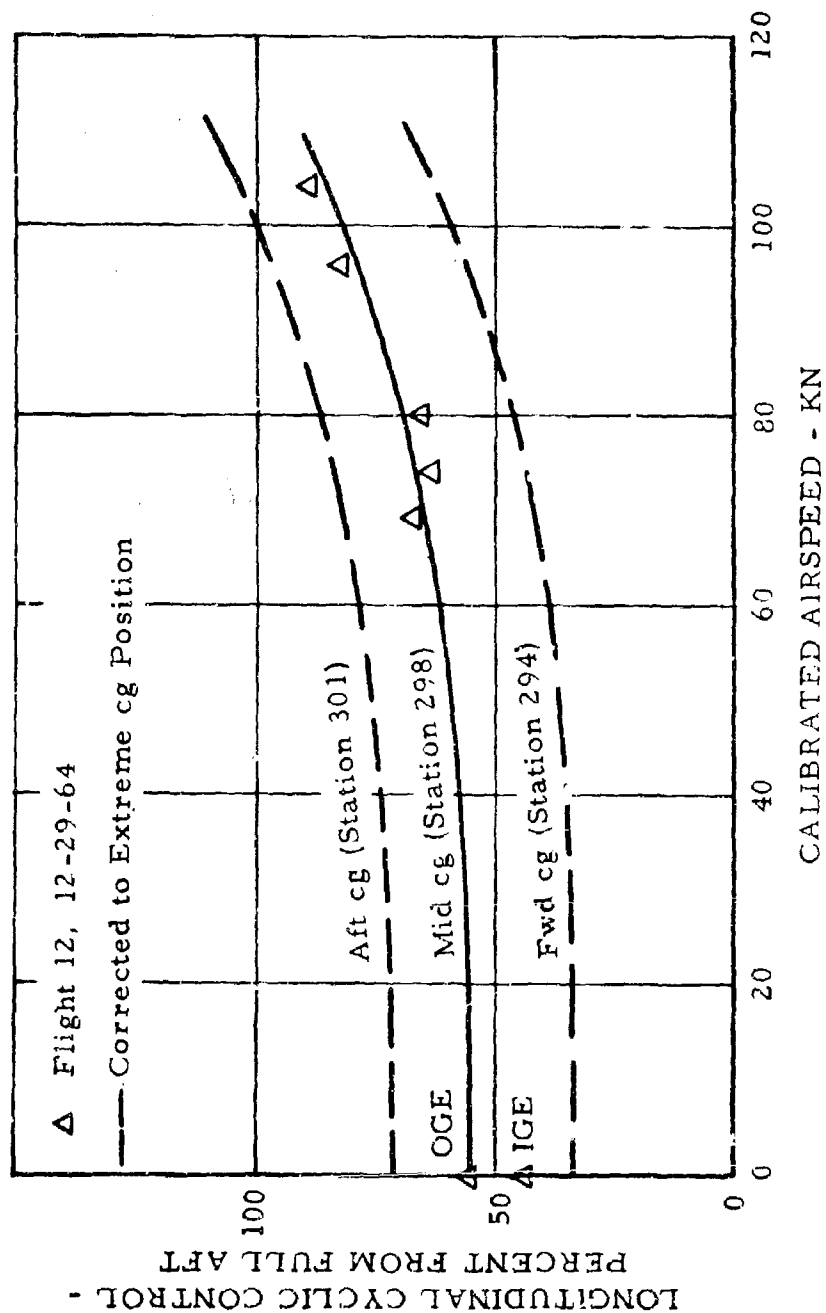
Gross Weight  $\approx 15,300$  lb  
 Sea Level Standard Day  
 $i_H = +3$

Figure 36. Level Flight Longitudinal Cyclic-Control Position Versus Airspeed.

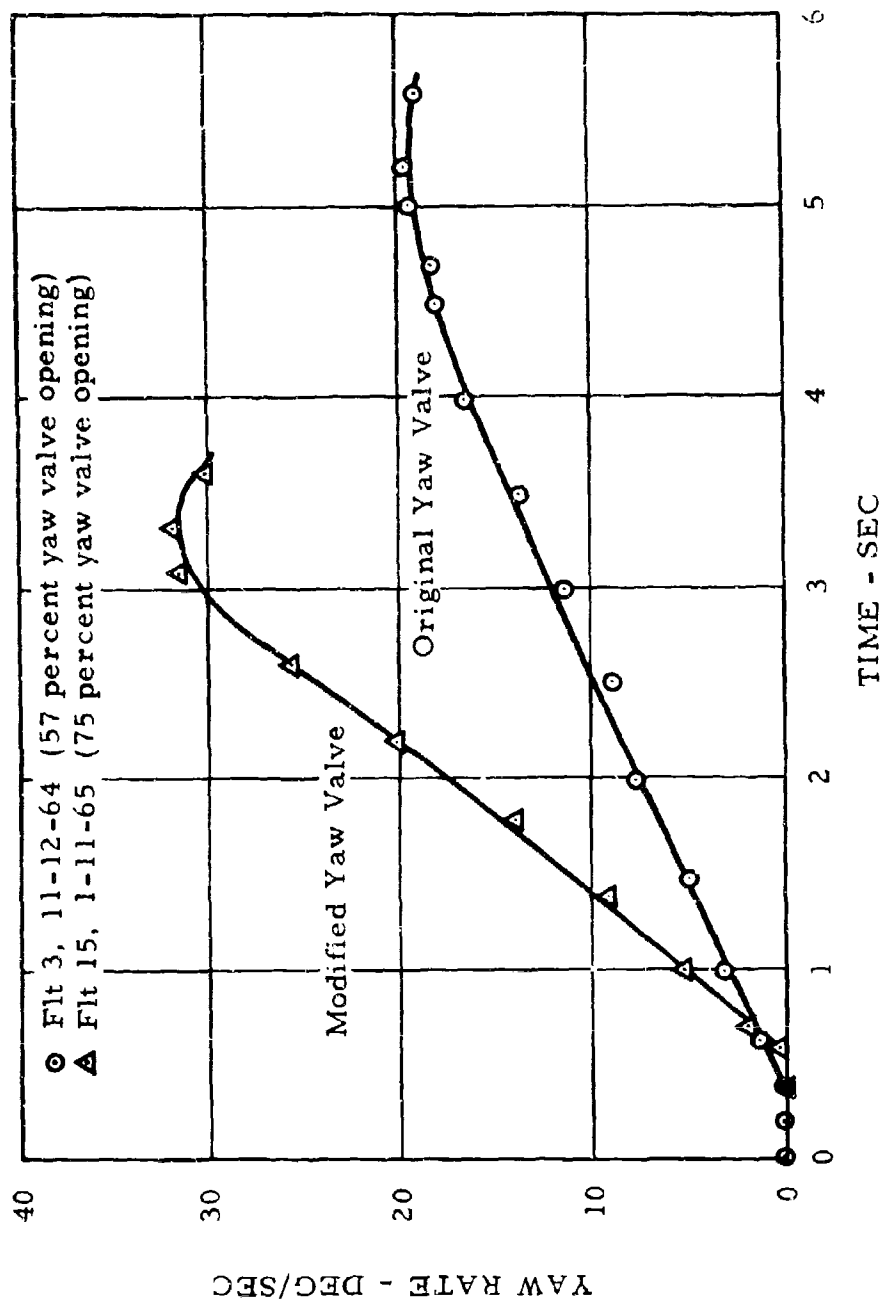
Gross Weight  $\approx$  15,300 lb

Figure 37. Full Pedal Deflection Hover Turns.

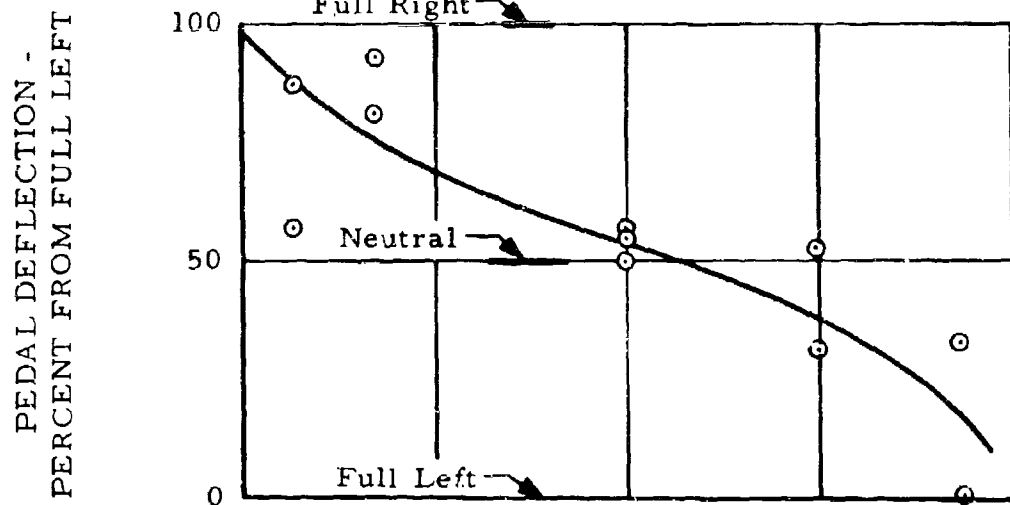
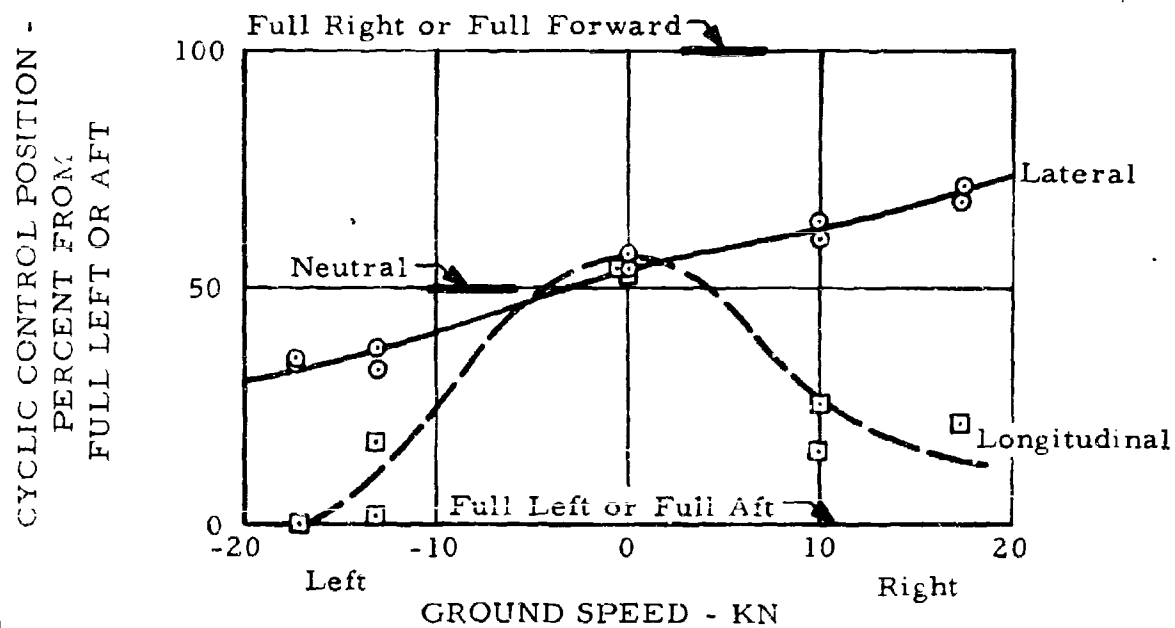
Gross Weight  $\approx 15,300$  lb  
 Lateral cg on Rotor  $\bar{C}_L$   
 Longitudinal cg = Station 298

Figure 38. Sideward Flight Control Position Versus Ground Speed.

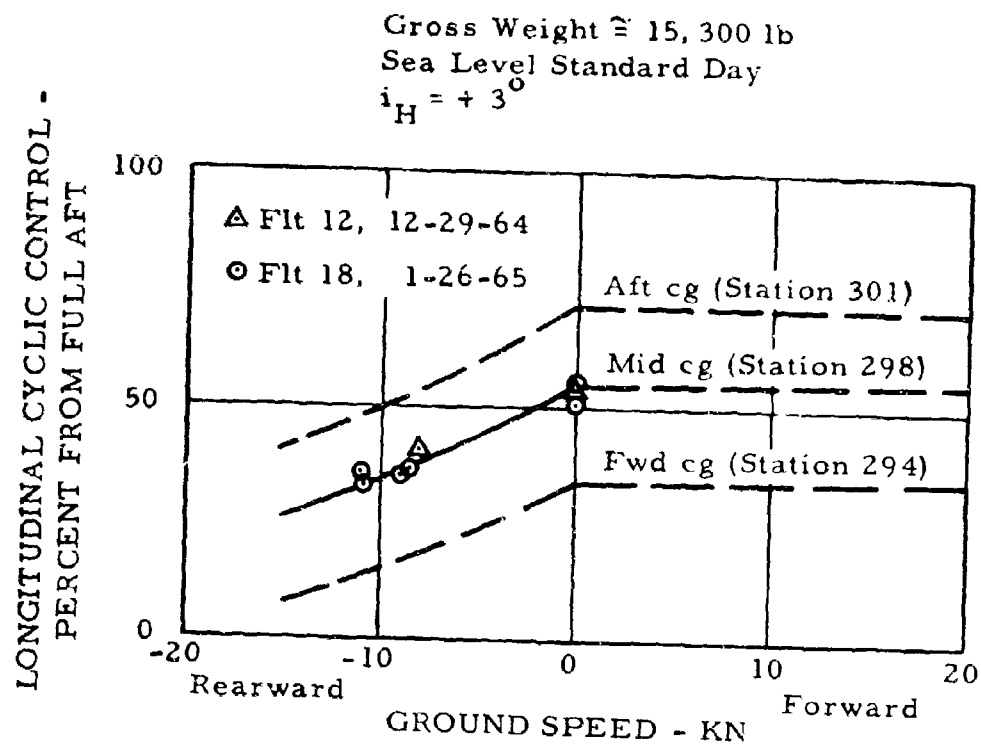
Figure 39. Rearward Flight Longitudinal Cyclic-Control Position Versus Speed.

at approximately 15 knots for the mid center of gravity location. For the critical forward center of gravity location, the maximum aft cyclic will limit the rearward speed to approximately 20 knots.

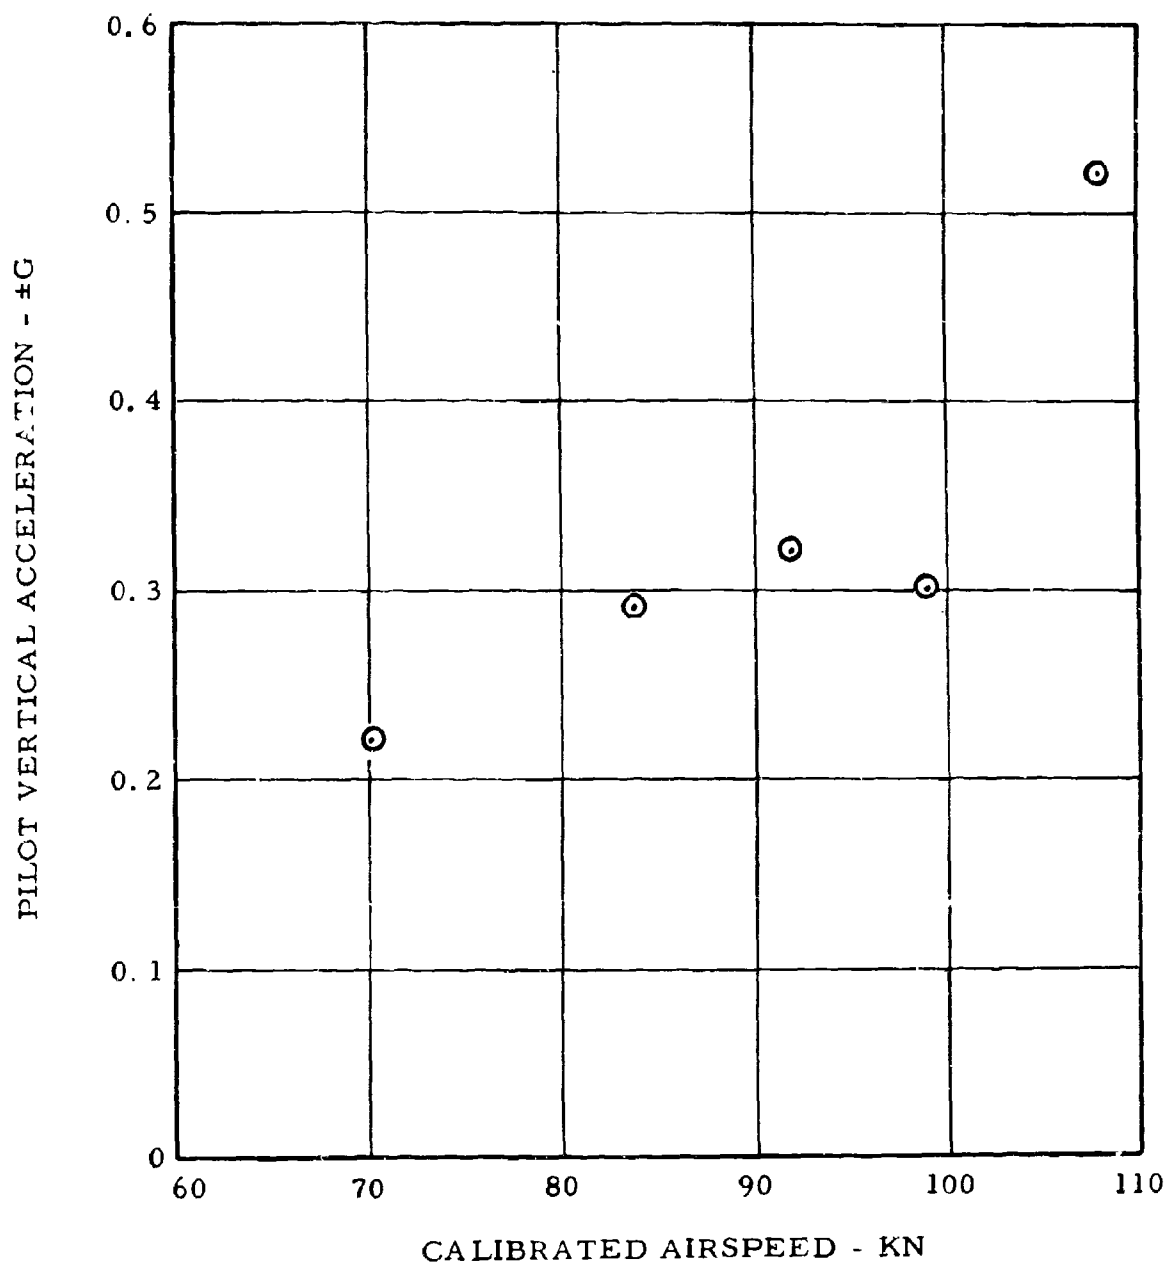
Figure 40. Maximum Pilot Vertical Acceleration Versus Calibrated Airspeed.

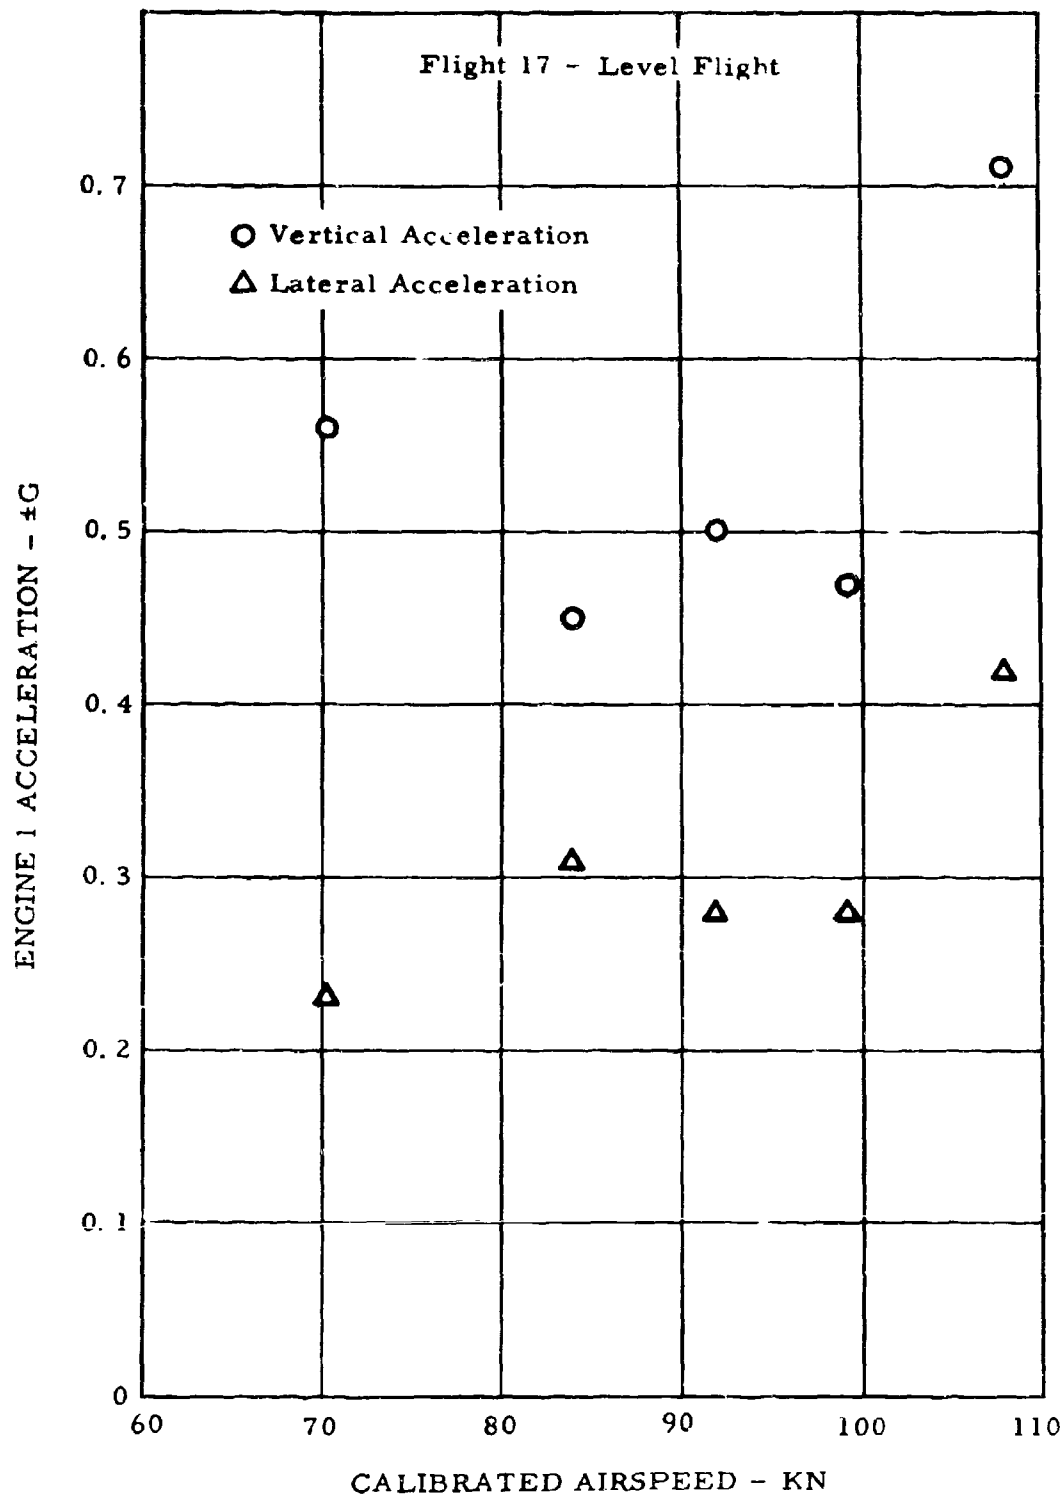
Figure 41. Maximum Engine 1 Acceleration Versus Calibrated Airspeed.

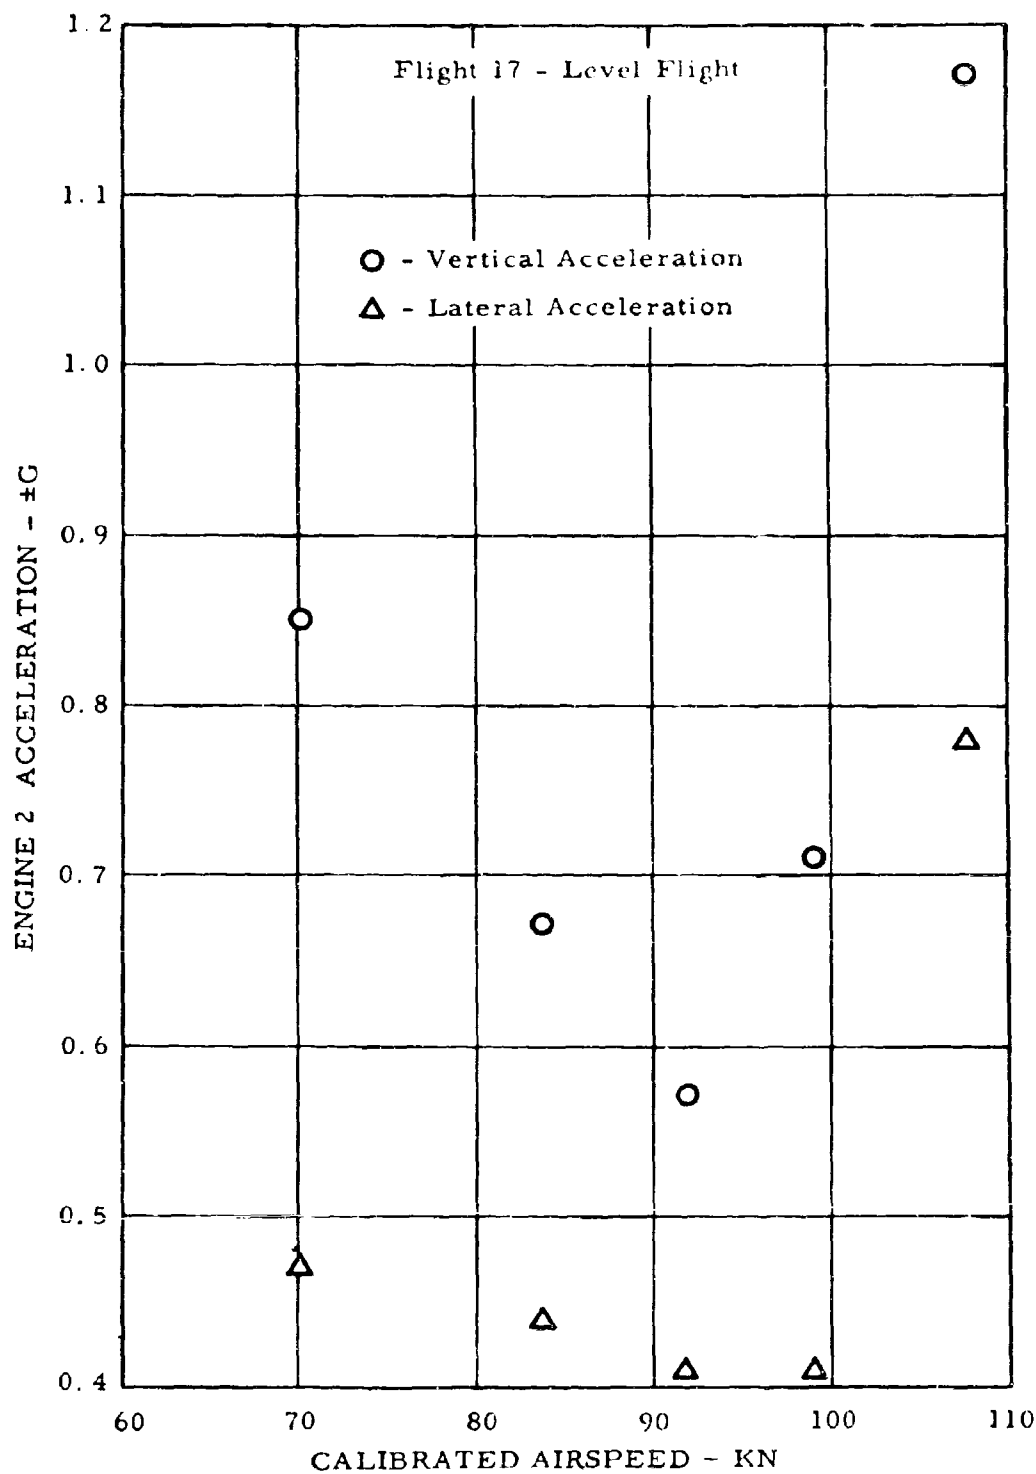
Figure 42. Maximum Engine 2 Acceleration Versus Calibrated Airspeed.

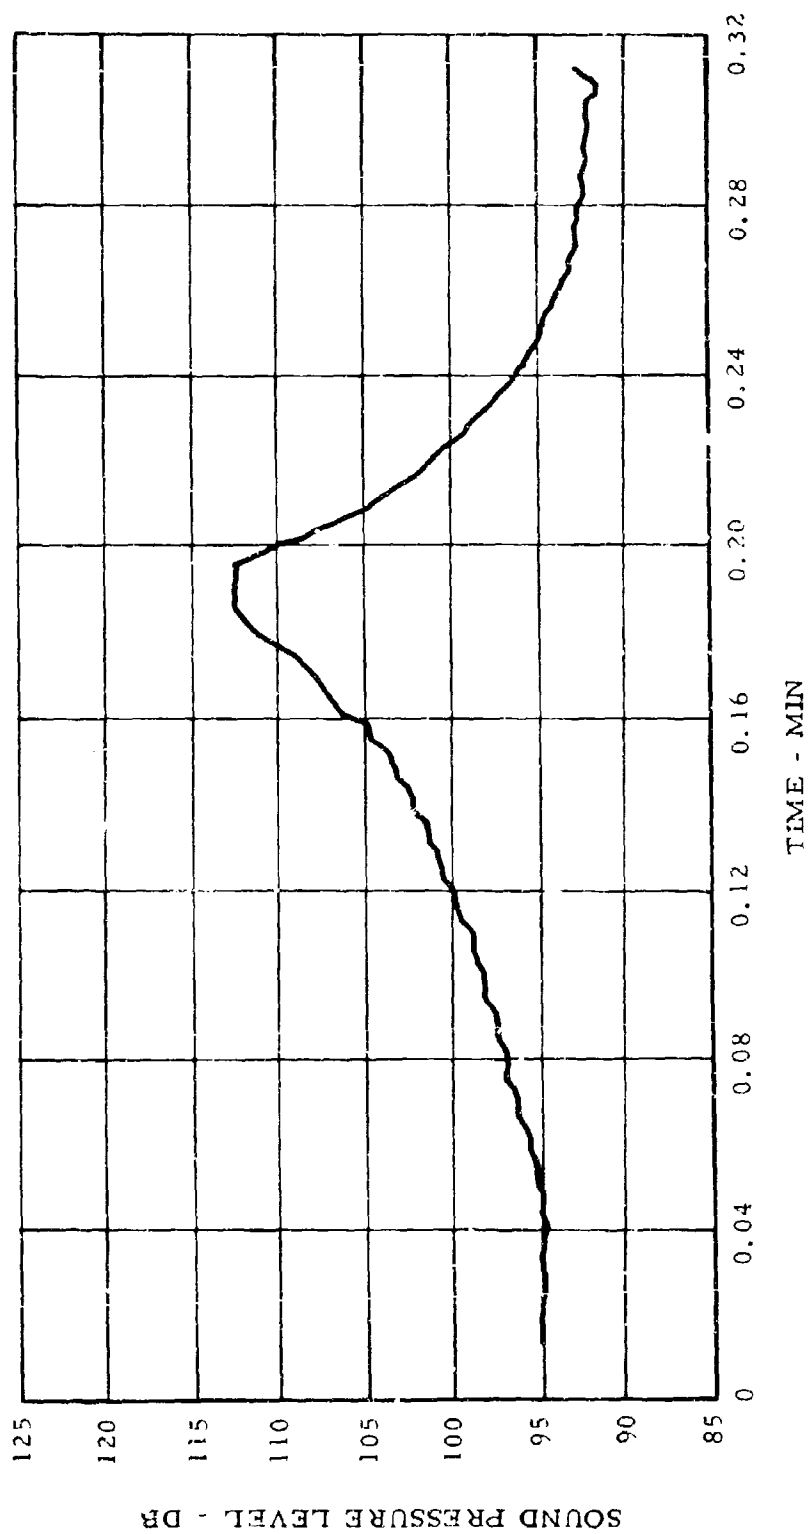
Flyover at 50-foot altitude, 90 knots

Figure 45. Sound Pressure Level In Flight.

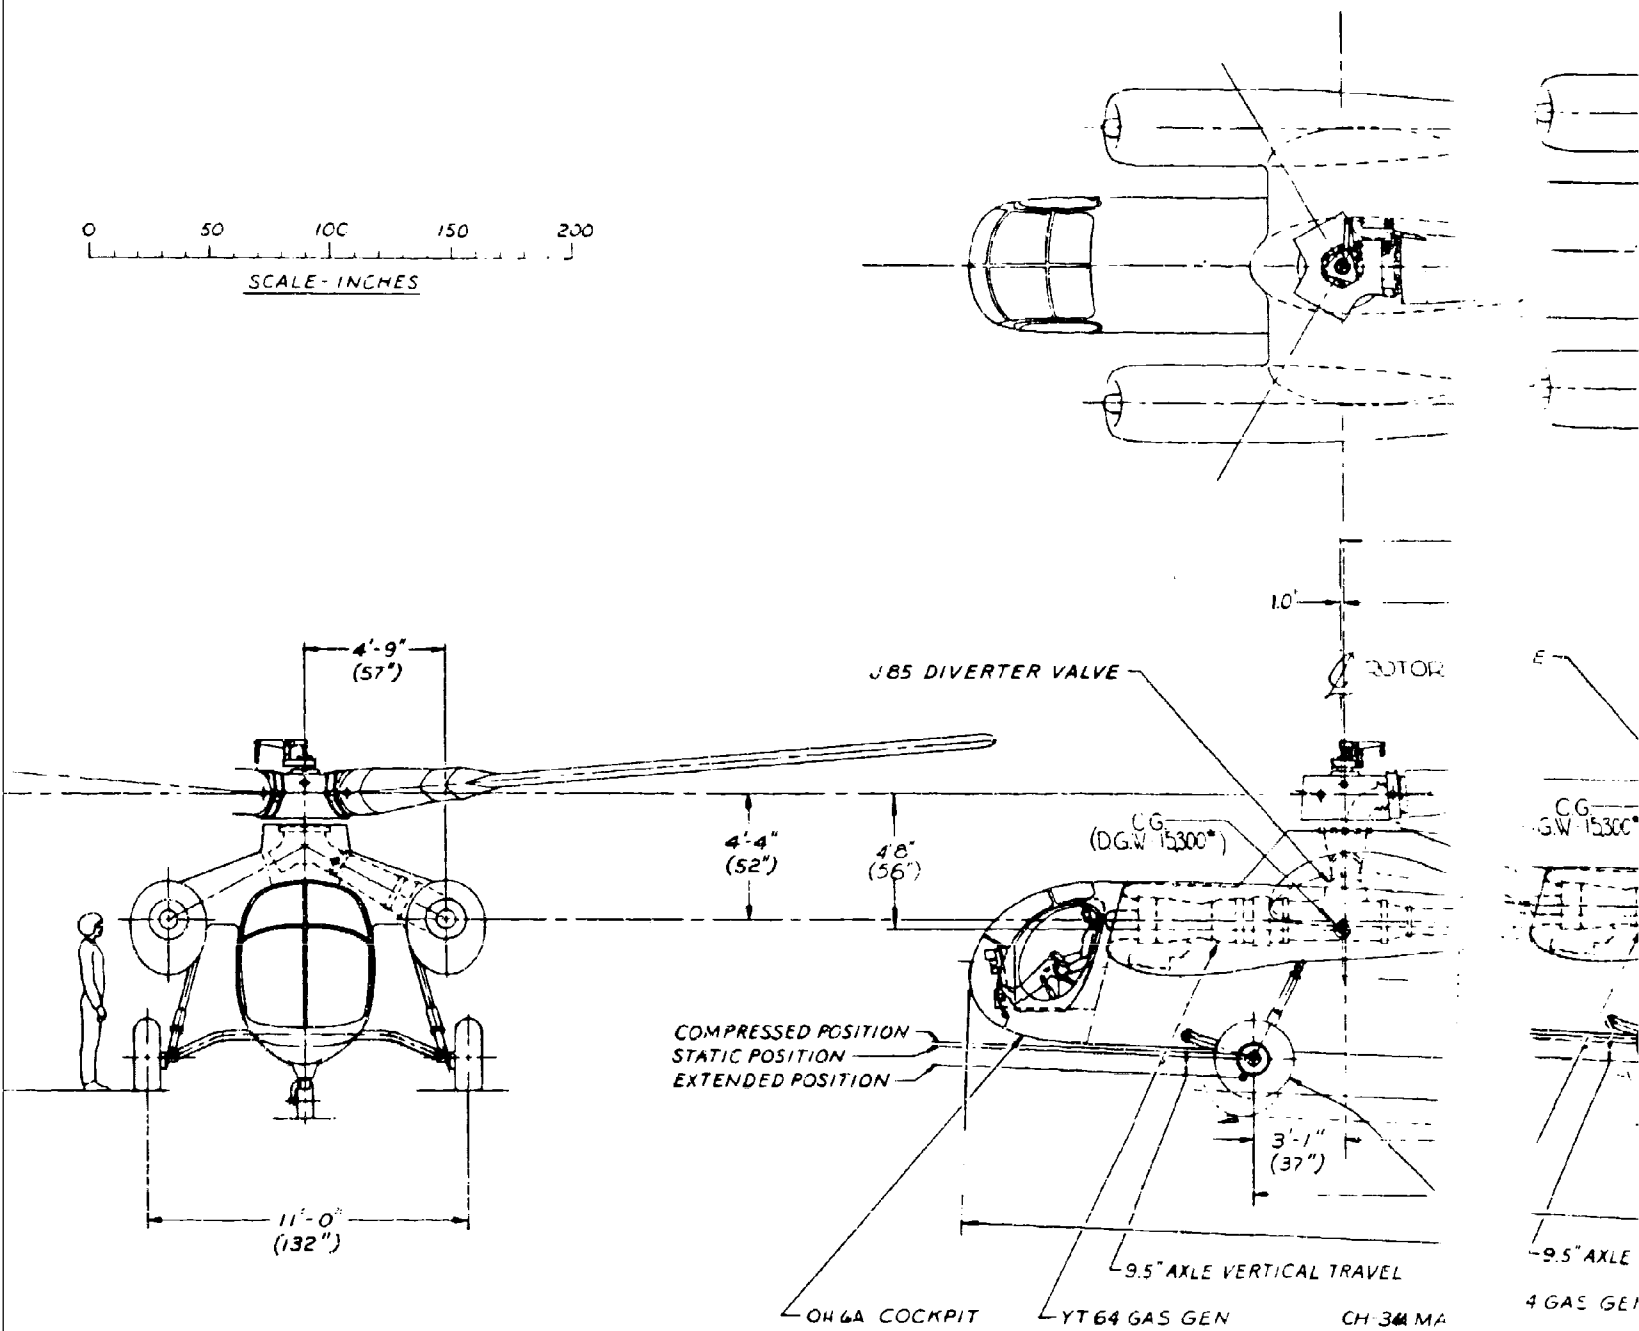
16. General Arrangement, XV-9A Hot Cycle Research Aircraft.

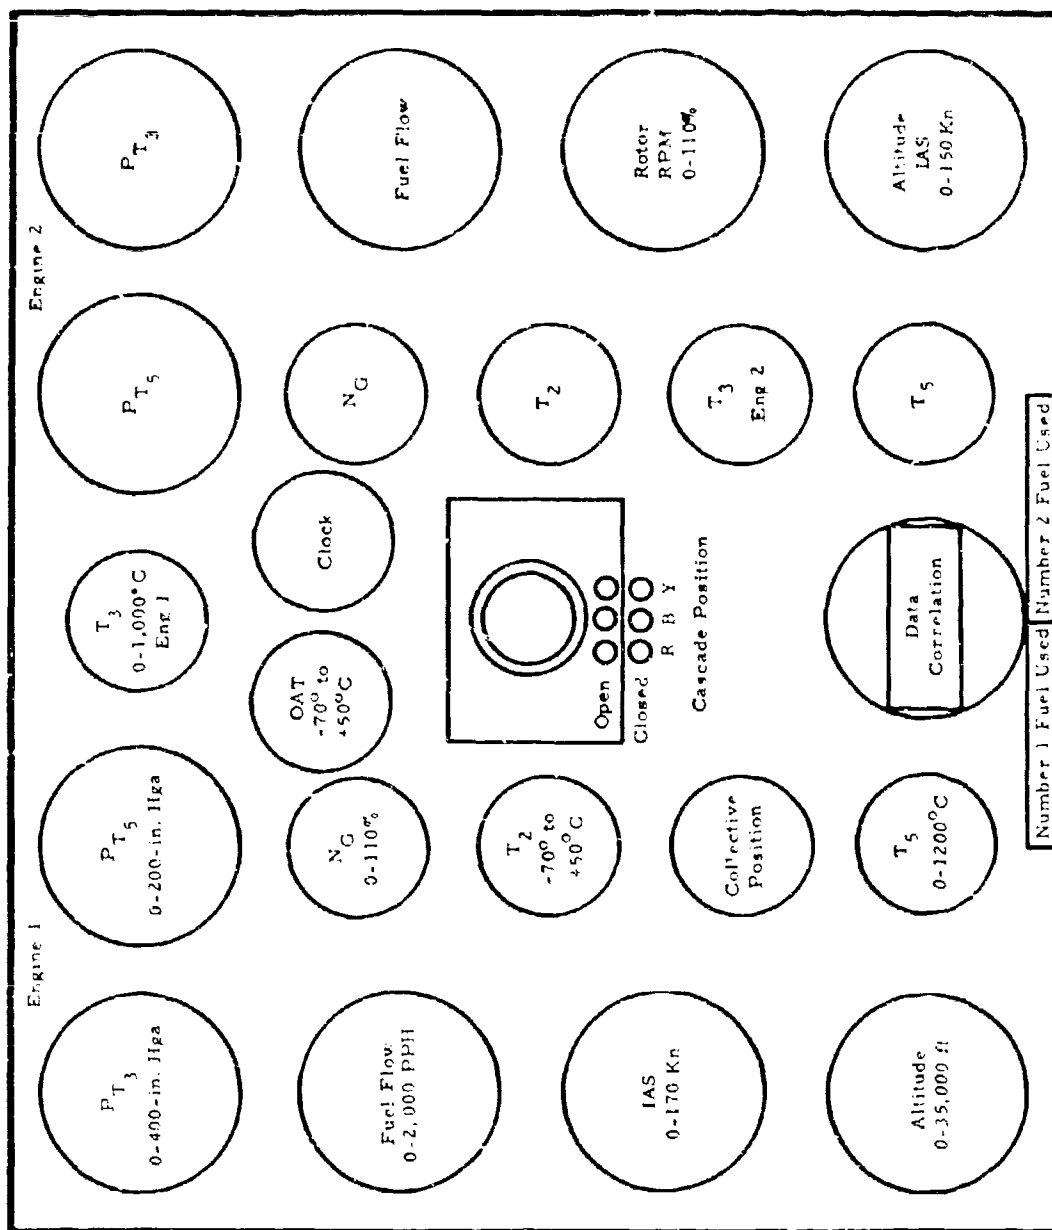
Figure 54. Photopanel Layout.

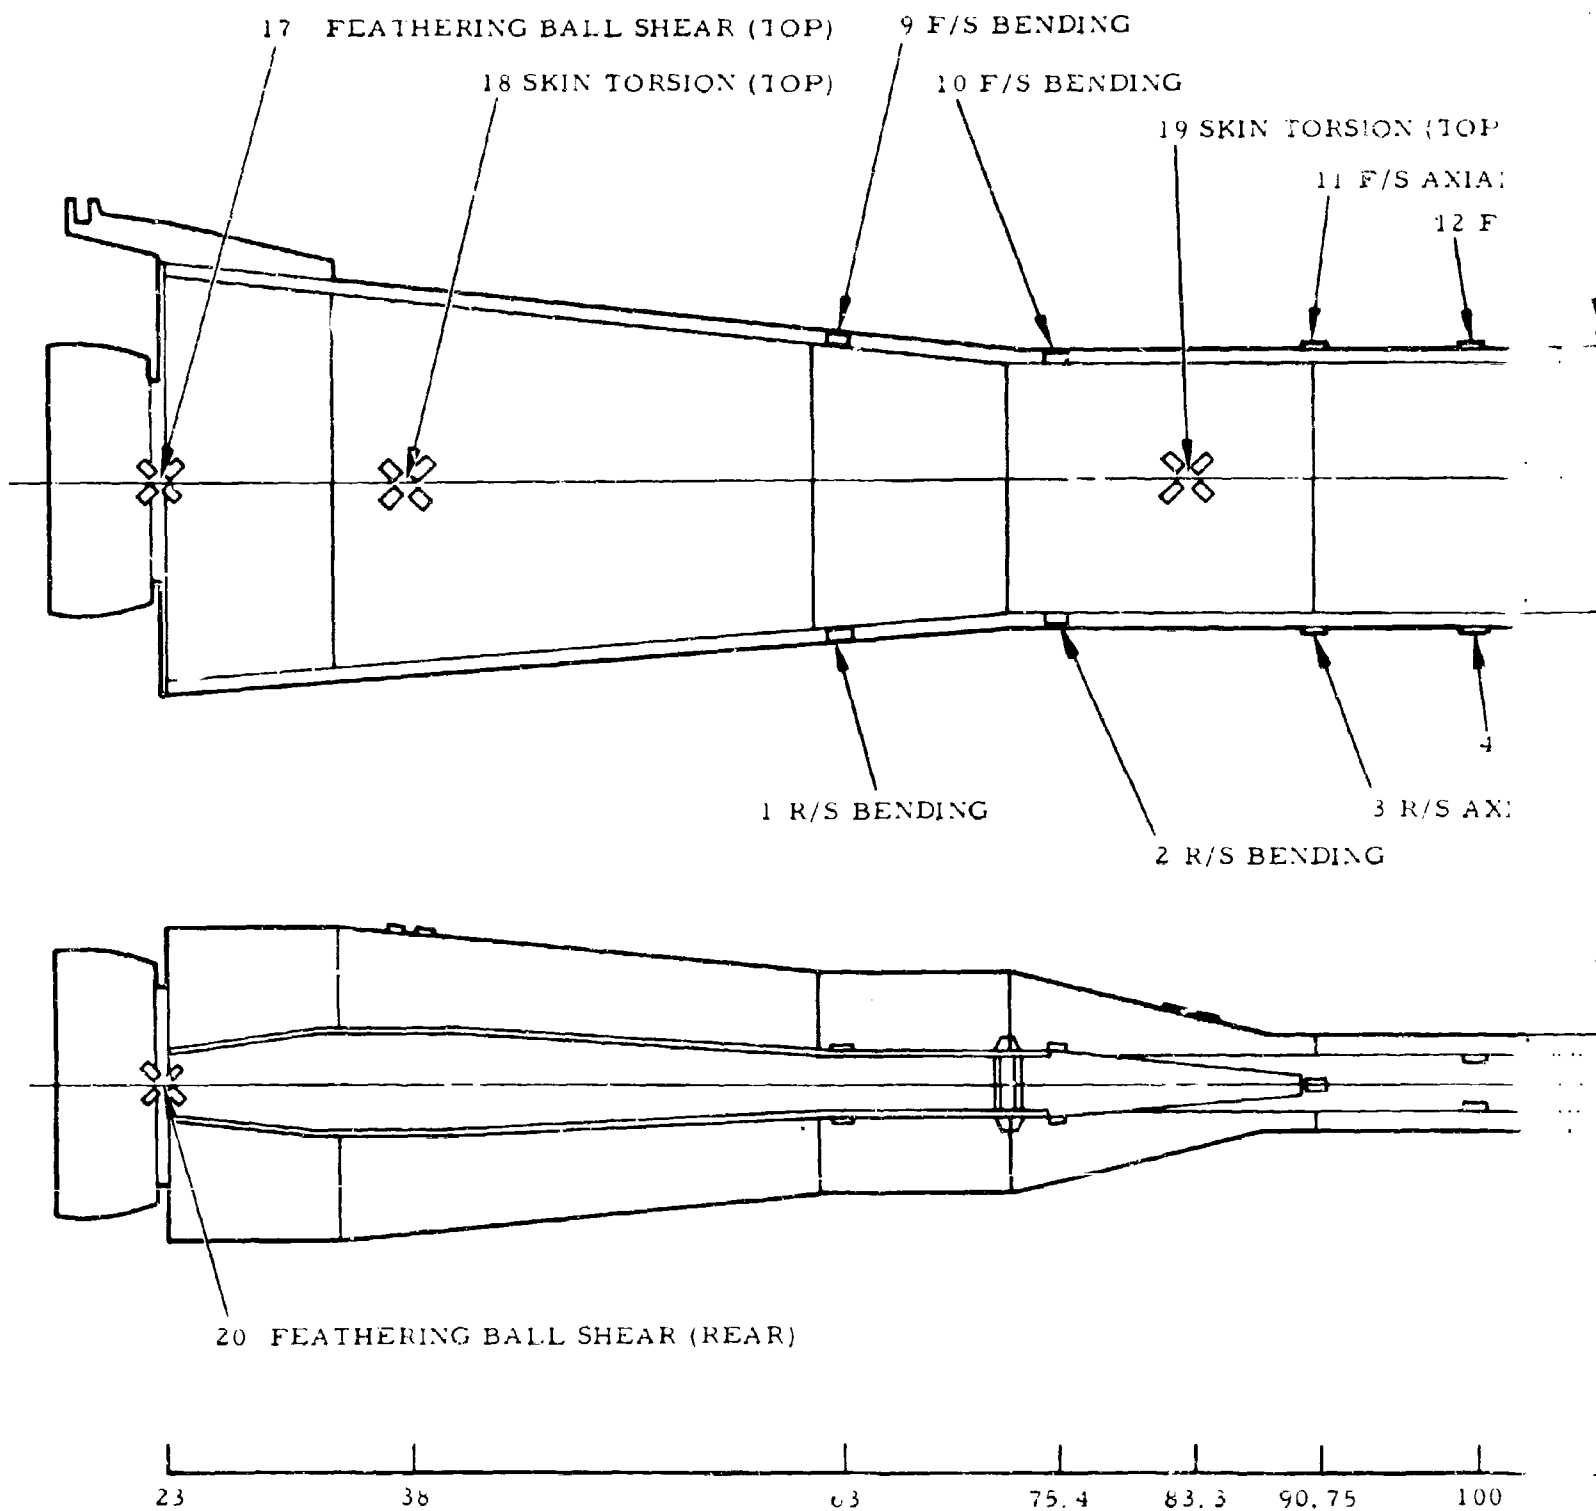
Figure 55. Strain-Gage Bridge Locations, Rotor Blades - Flight Test.

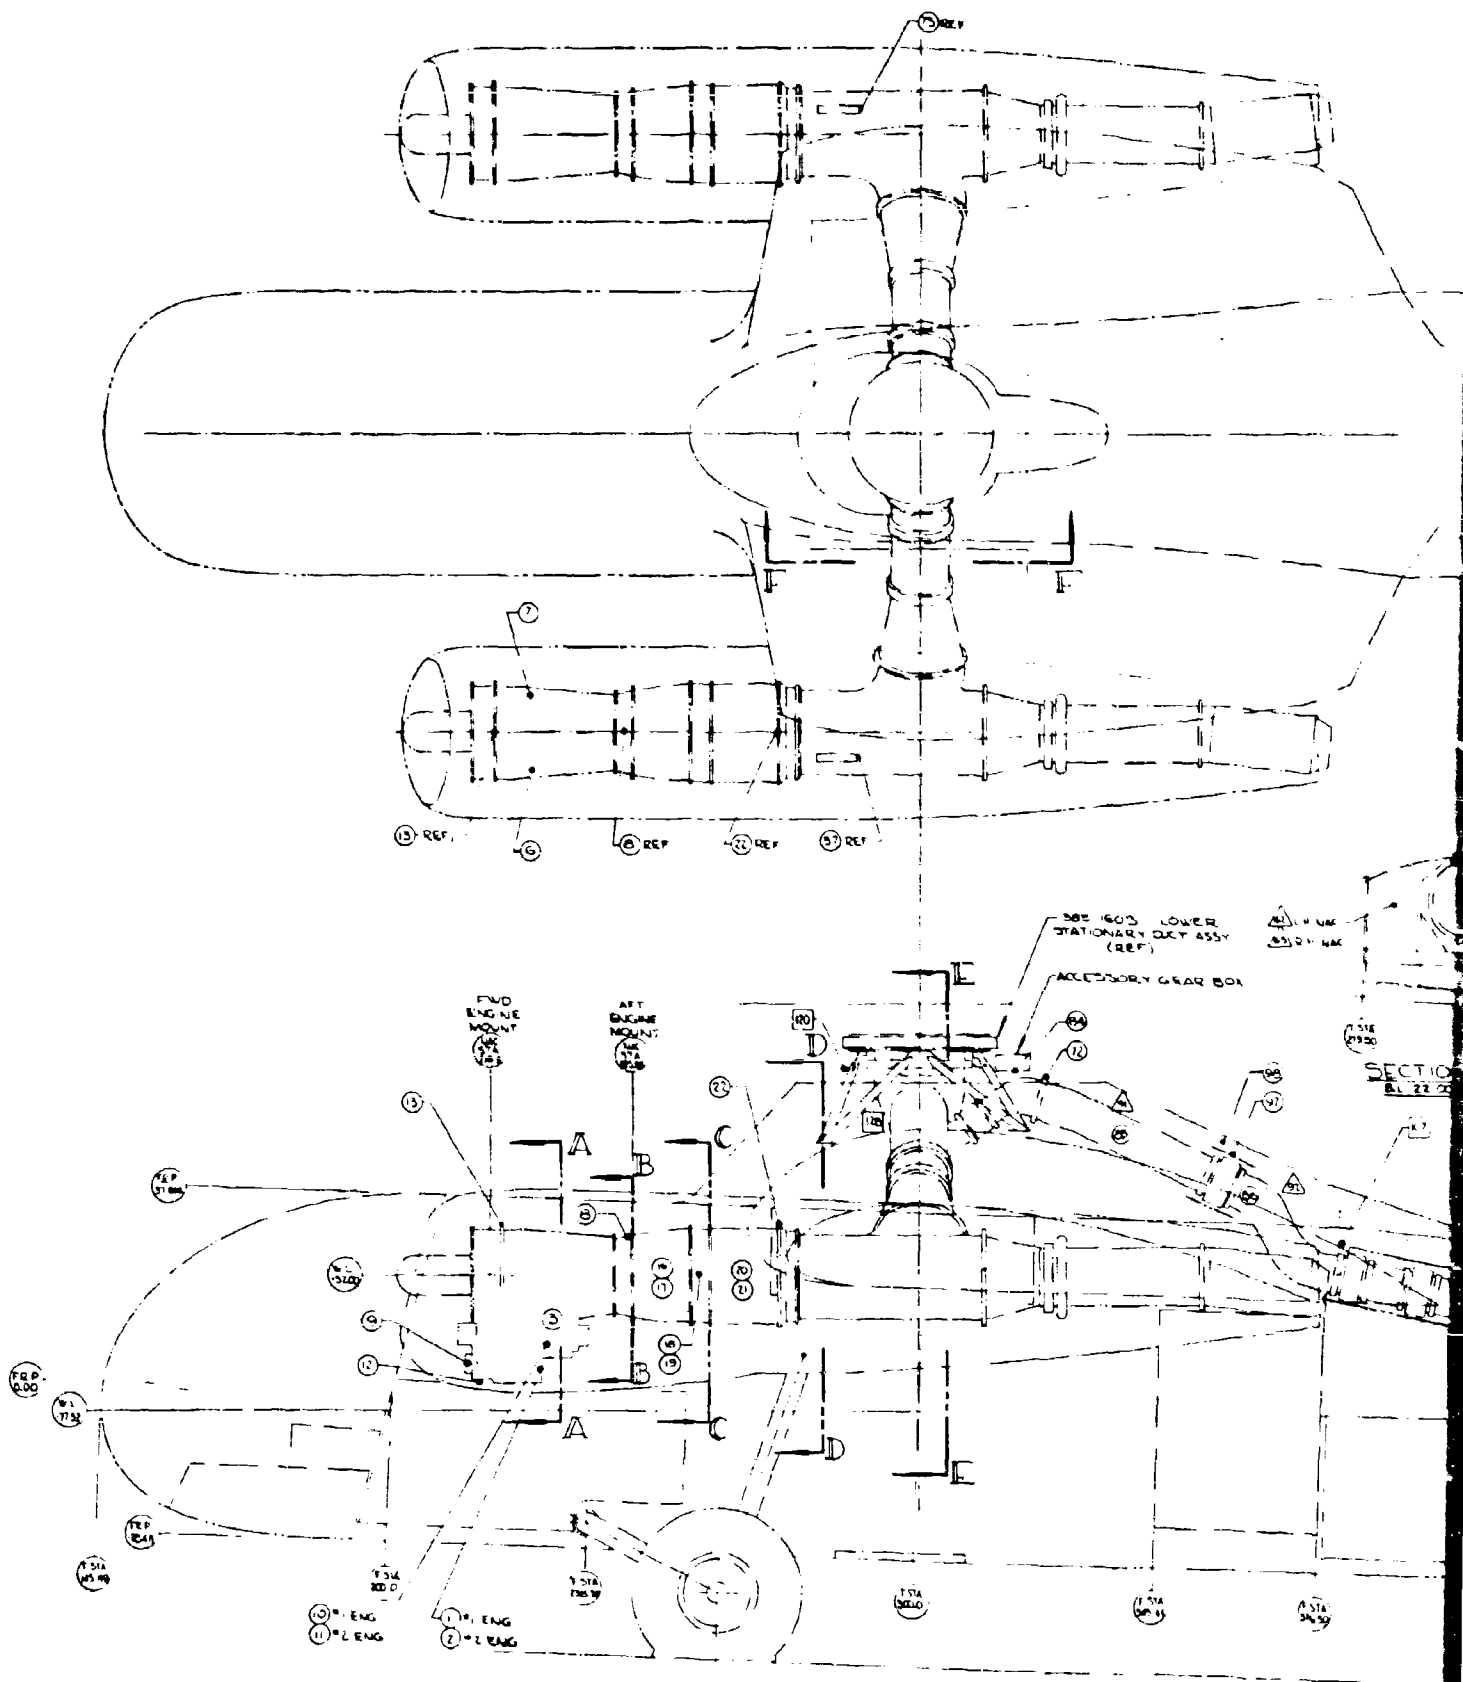
Figure 58. Thermocouple Location, Hot Gas System.

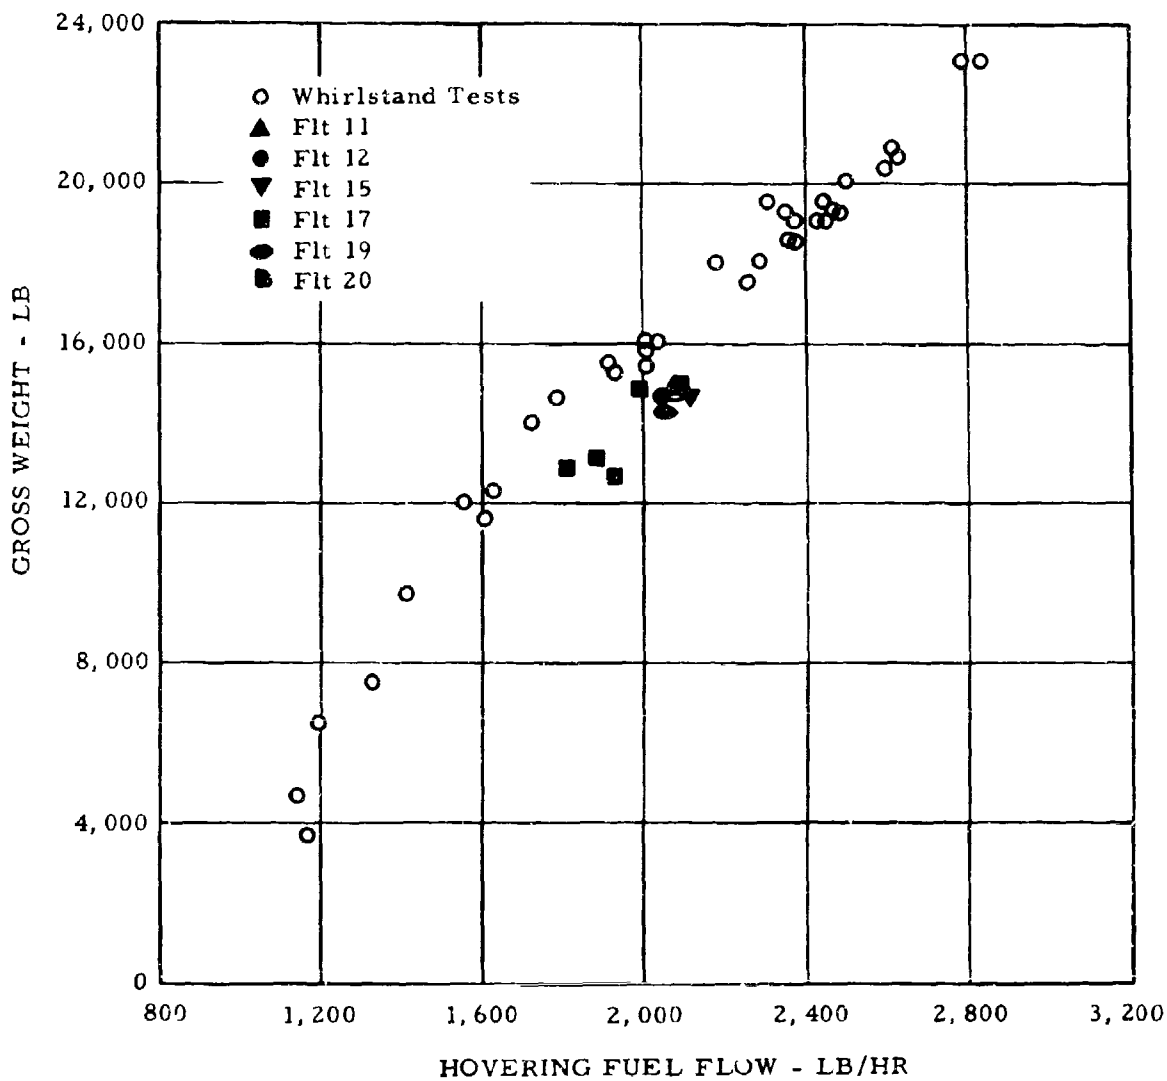
Figure 59. Observed Hovering Fuel Flow Versus Gross Weight.
